**Organization**  
Skand Pty. Ltd.

**Location**  
Victoria, Australia

# Skand Delivers Integrated 3D Model and Asset Lifecycle Program for a University Campus

ContextCapture Sped-up the Project Four Times Faster, Saving AUD 70,000

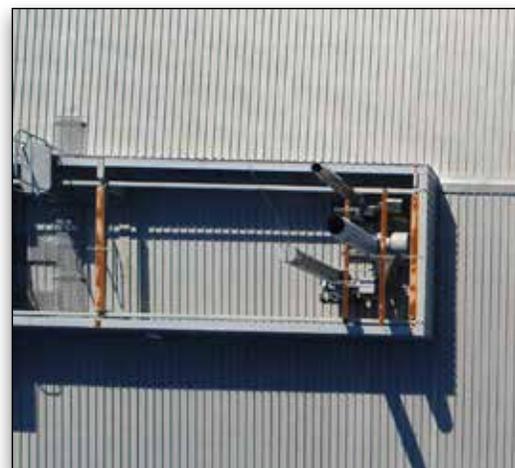
Skand projects AI-identified defects onto the ContextCapture reality mesh including forms of corrosion and building material degradation.

Using artificial intelligence (AI), Skand can identify and categorize defects when analyzing the 2D images and then project these defects onto the 3D reality mesh. ContextCapture helped the project team create 16 categories of defects on both the roofs and facades, including cracks, moss, algae, rust, and other forms of corrosion and building material degradation. Skand’s web application displays the ContextCapture 3D reality mesh with the detected defects mapped out, creating an inspection and condition report powered by Power BI.
